SERVICE BULLETIN NO. SB-08-093

SUBJECT: ConMet, Potential for Water Contamination in Hub Lubricant Due to Flooding in South Central US.

#10016583 September 29, 2005

Service Alert: Potential for Water Contamination in Hub Lubricant Due to Flooding in South Central US

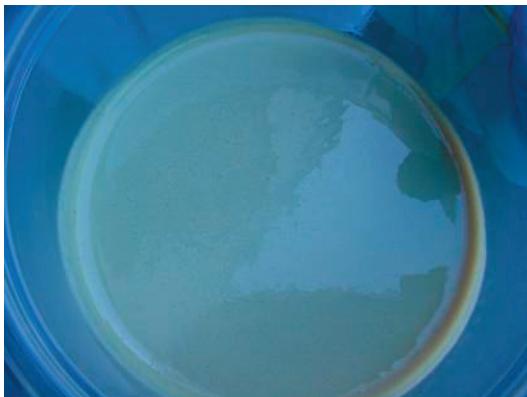
A visual inspection of the hub lubricant is advised. Oil, such as a 50 weight synthetic, with a small amount of water added will turn to become a milky white color (figure 1). Semi-fluid grease will also turn a milky color. However the color change will depend on the grease's base color. Figure 2 shows semi fluid grease after water contamination. Its base color was a red/pink color and after contamination the lubricant has turned a milky shade of pink.

Figure 1: 50 weight synthetic oil contaminated with a small amount of water turns milky white.

Contaminated lubricant should be removed from hub assembly and replaced with new lubricant. Hub cavity should be thoroughly cleaned to ensure removal of all contaminated lubricant.

Contaminated lubricant must be removed from the wheel end to prevent wheel bearing damage. Failure to remove contaminated lubricant will void ConMet PreSet warranty.

Inspect bearing cups and cones for water corrosion, rusting and any unusual signs of wear. Replace bearings if necessary with appropriate bearing set.

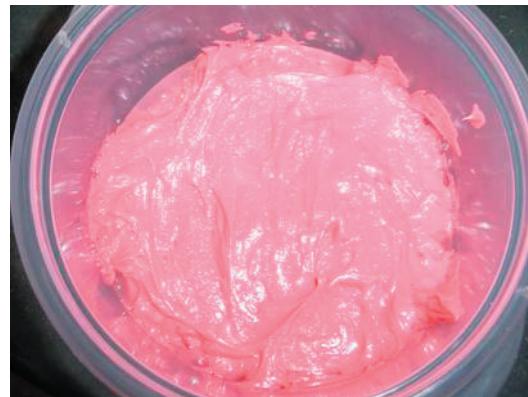
Figure 2: Red/pink semi-fluid grease contaminated with a small amount of water turns milky pink.
