SERVICE BULLETIN NO. SB 08-117

SUBJECT: TECH TIP # 13 - STEMCO SENTINEL HUBCAP VENTING

Tech Tip #13

Sentinel Products & Internal Vacuum

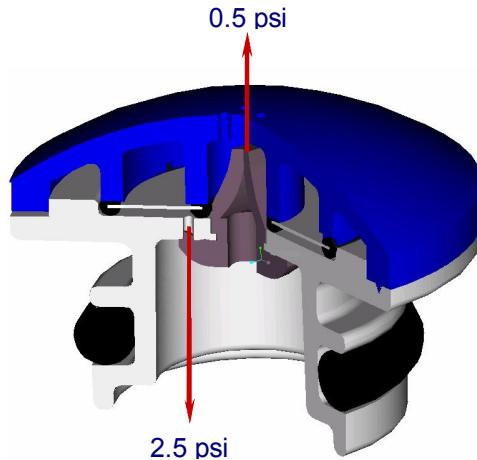
During the removal of a Sentinel ESP, the sound of air pressure being relieved may be observed. This sound has been confused as a buildup of internal pressure within the hub cavity, giving the perception that the vent is clogged. In reality, the sound of air is actually from the relief of a slight vacuum generated within the hub during vehicle cool down. This vacuum occurs because of a differential between the outbound and inbound check valve cracking pressures (shown in the Figure at right) designed into the Sentinel system as part of its contaminant exclusion function. It is present for both the Sentinel Hub Cap and the ESP. Please note that this vacuum does not affect seal performance for three primary reasons:

Second, vacuum in the hub occurs only after the vehicle has been static long enough to cool down from its operating temperature. For example, when the vehicle initially starts its trip, the hubs begin to heat up from friction. The air inside expands and is vented out through the Sentinel outbound (duckbill) check valve at a very low pressure (typically 0.5 psi or less). The pressure inside is equalized quickly, allowing the valve to close and prevent contamination of the hub. After the vehicle is stopped, the hubs begin to cool down. At this point, the air inside contracts thus lowering the pressure. Once this air pressure drops to the inbound (umbrella) check valve's cracking pressure (typically 2.5 psi or less), the valve opens allowing air into the hub. The vacuum is relieved to prevent it from reaching levels too high for the oil seal. The incoming air must pass through the Sentinel's patented filtration design, thus preventing

contaminant entry. Once the vacuum has been relieved to an acceptable level, the inbound valve closes.
