SERVICE BULLETIN NO. SB-13-002

SUBJECT: Bustin Pull Out Platform Service Bulletins for models POS-204, TAP-200, POA59, and POA60.

Service Bulletin Aluminum Pullout TAP-200 and POA59 and POA60

Steel Pullout POS-204 Service Bulletin

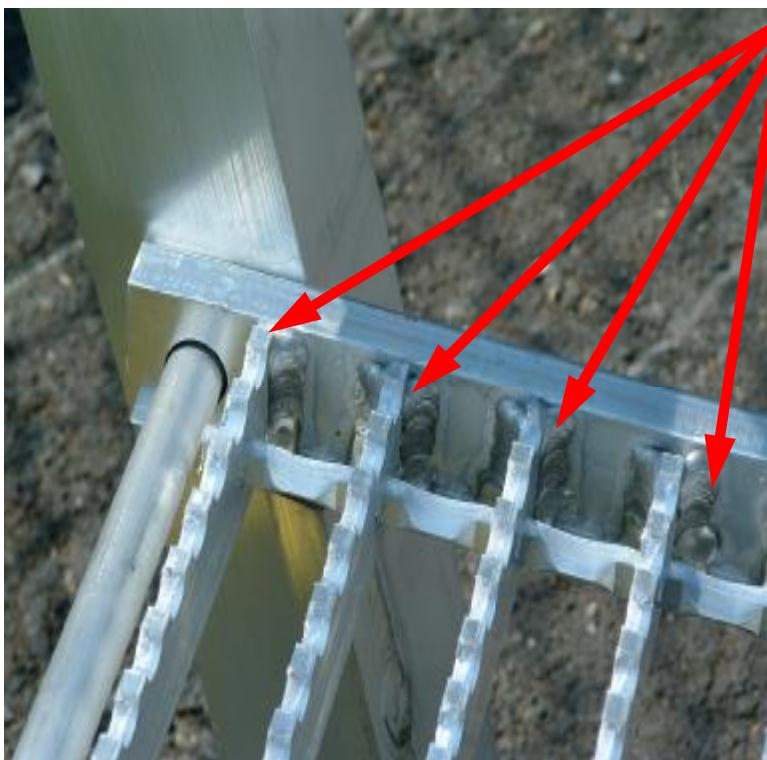
1) Bearing Bar Welds

The Steps on Older Aluminum TAP-200, POA59&60 Pullout Platforms may be subject to weld breakage and eventual failure of the step. This could result in a fall injury. These units were produced prior to 2003. Steps produced that time are fully welded.

Please inspect all steps on aluminum pullouts to determine if all bearing bars are welded on both sides of each bar. (Note: The last bar is welded one side only)

If the bars are not welded both sides, as shown, the complete step should be replaced.

Simply remove the tie bar bolt holding the left and right stair stringers in position.

Pull the 2" square aluminum tube stringers apart and the steps can be removed and replaced.

Refasten the tie bar bolt using a new self locking nut (provided with step).

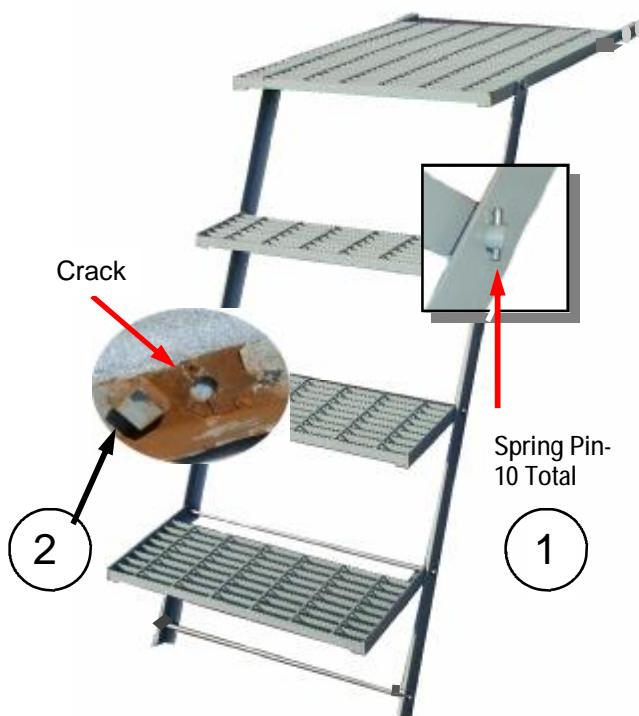
The Steel Pullout Platform Model number POS-204 has experienced unacceptable service life, requiring a higher level of maintenance than normally attributed to Bustin products. We have received reports of two incidents attributable to steps dropping out of position.

Please inspect all pullouts to determine if spring pins are used on your ladder stringers. Verify pins are centered in the step pivot rod. Uncentered roll pins may loosen. Loose pins can pose a safety problem if the pin falls out resulting in one side of the step to drop. The spring pins must be replaced with stainless steel cotter pins and washers available from Bustin.

Ladder stringers can become damaged in use. Check for significant bending damage of steel angle legs on ladder. If bending is present, check all pivot rod holes in the stringer for possible cracks in the base metal near the holes. Replace any damaged stringers or stringers with cracks.

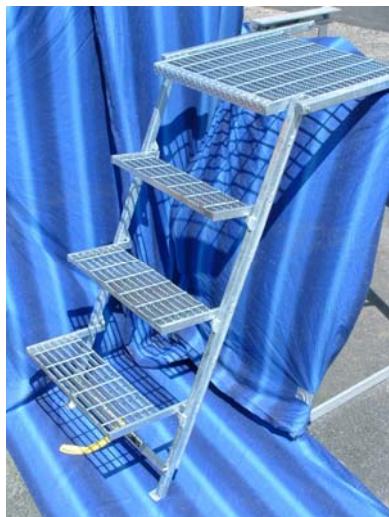
OPTION #1 POS400G Steel

For \$110 each, option number 1 is an upgrade to a galvanized steel POS400G pullout platform. The POS400G is a heavy-duty steel pullout platform with **square tubing legs (1-1/4")** and **landing frame (1-1/2")**, The POS400G fits into your existing enclosure and can be quickly installed.

Upgrade the steel pullout platform to the **Heavy Duty Galvanized Steel** POS400G for \$110 each.
Capacity 600# Weight: 125#.

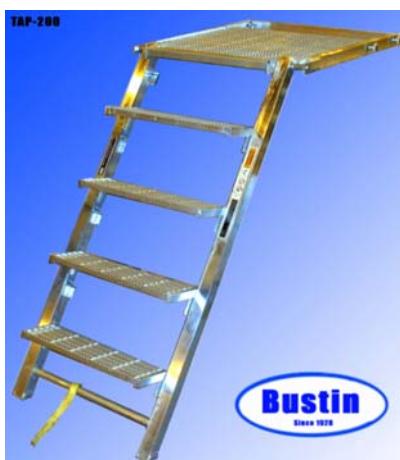
OPTION #2 TAP200 Aluminum

For \$110 each, option number 2 is an upgrade to an aluminum TAP200 pullout platform. The TAP200 is a heavy-duty aluminum pullout platform with **2" square tubing legs** and a **2" custom extrusion** at the landing, The TAP200 fits into your existing enclosure and can be quickly installed.

Upgrade the steel pullout platform to the **Heavy Duty aluminum light weight** TAP200 for \$110 each.
Capacity 500# Weight: 60#.
